FORT BLISS, POST HOSPITAL  
(Post Headquarters)  
(Building One)  
Pershing Road  
El Paso  
El Paso County  
Texas

HABS TX-3339-R  
TX-3339-R

FORT BLISS, POST HOSPITAL  
(Fort Bliss, Post Headquarters)  
(Fort Bliss, Building 1)

HABS No. TX-3339-R

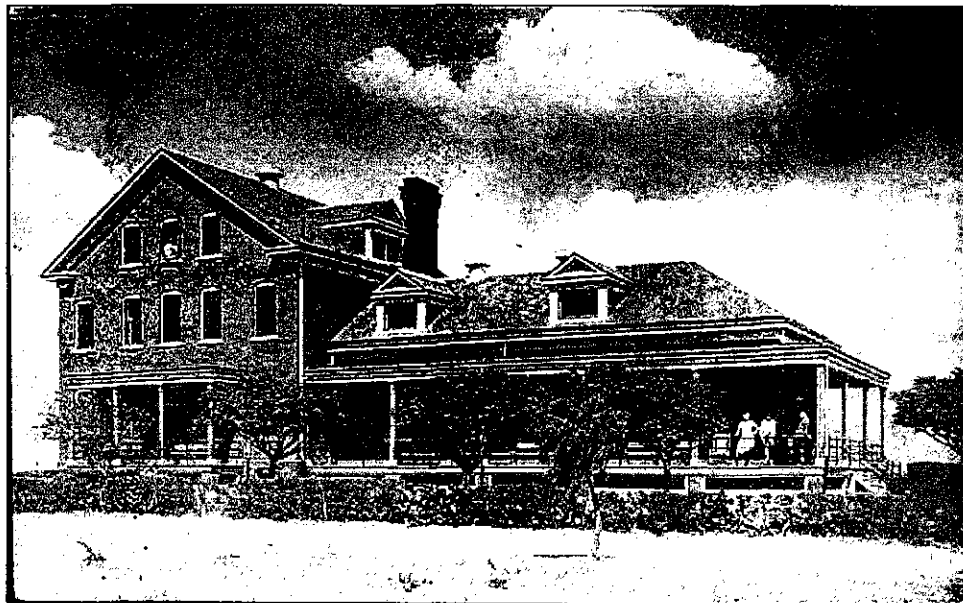
*Figure 1. Building 1, 1904-1914. Source: Fort Bliss Historical Archives.*

Building 1 was constructed in 1904 to replace the original hospital housed in Buildings 8 and 9. (The need for beds was greater than anticipated and Buildings 8 and 9 continued to be used as hospitals until the completion of the William Beaumont General Hospital in 1921.) Although built after the first construction period (1891-1899) of Fort Bliss, it followed Captain George Ruhlen's original design plan in which officers' quarters were on the west side of the parade ground and buildings for the enlisted men, such as barracks, mess halls, and the hospital, were on the east. As the 28th building on the post, it was the first building of the interim building period between 1900 and 1912. The original structure consisted of a central administration area with a one-story ward on the south side that held approximately 12 beds.

2. Historic landscape design: Building 1 was constructed during the Interim Period of development at Fort Bliss (1900-1912). Early photographs of the facility (see Figures 1 and 2) show it surrounded by a low hedge with small trees on the west and south. Pershing Road was a narrow, unpaved lane and the Parade Ground was covered in native vegetation.

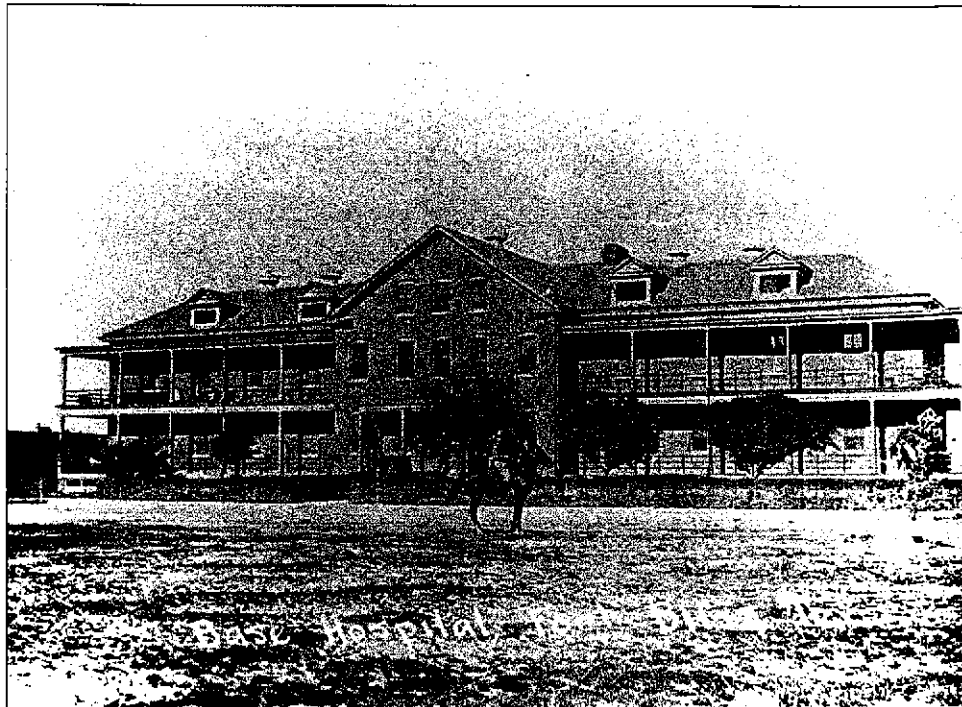
*Figure 2. Building 1, after 1914. Source: Fort Bliss Historical Archives.*

This change in mission and influx of soldiers led to a significant expansion on the post (the First Expansion Period, 1913-1917), and the hospital was expanded to meet the increased demand for services. Therefore, in 1912 Army architects designed a second floor for the south wing and a two-story north wing. These two additions were completed c. 1914. In 1916, a rear annex was constructed to accommodate dormitories and a kitchen/mess hall. Additionally, the Army built an isolation ward (Building 4) and an ambulance garage (Building 5) to the rear of Building 1. Named Department Base Hospital Number 2 in March 1916, the new facility housed 93 beds.
